FAILURE ANALYSIS OF A RUPTURED BOILER TUBE

A refinery boiler had experienced a rupture failure on Tube #69 of the east water wall near the roof tubes. The tube material was ASTM A192 plain carbon steel and had been in service for approximately thirty years.

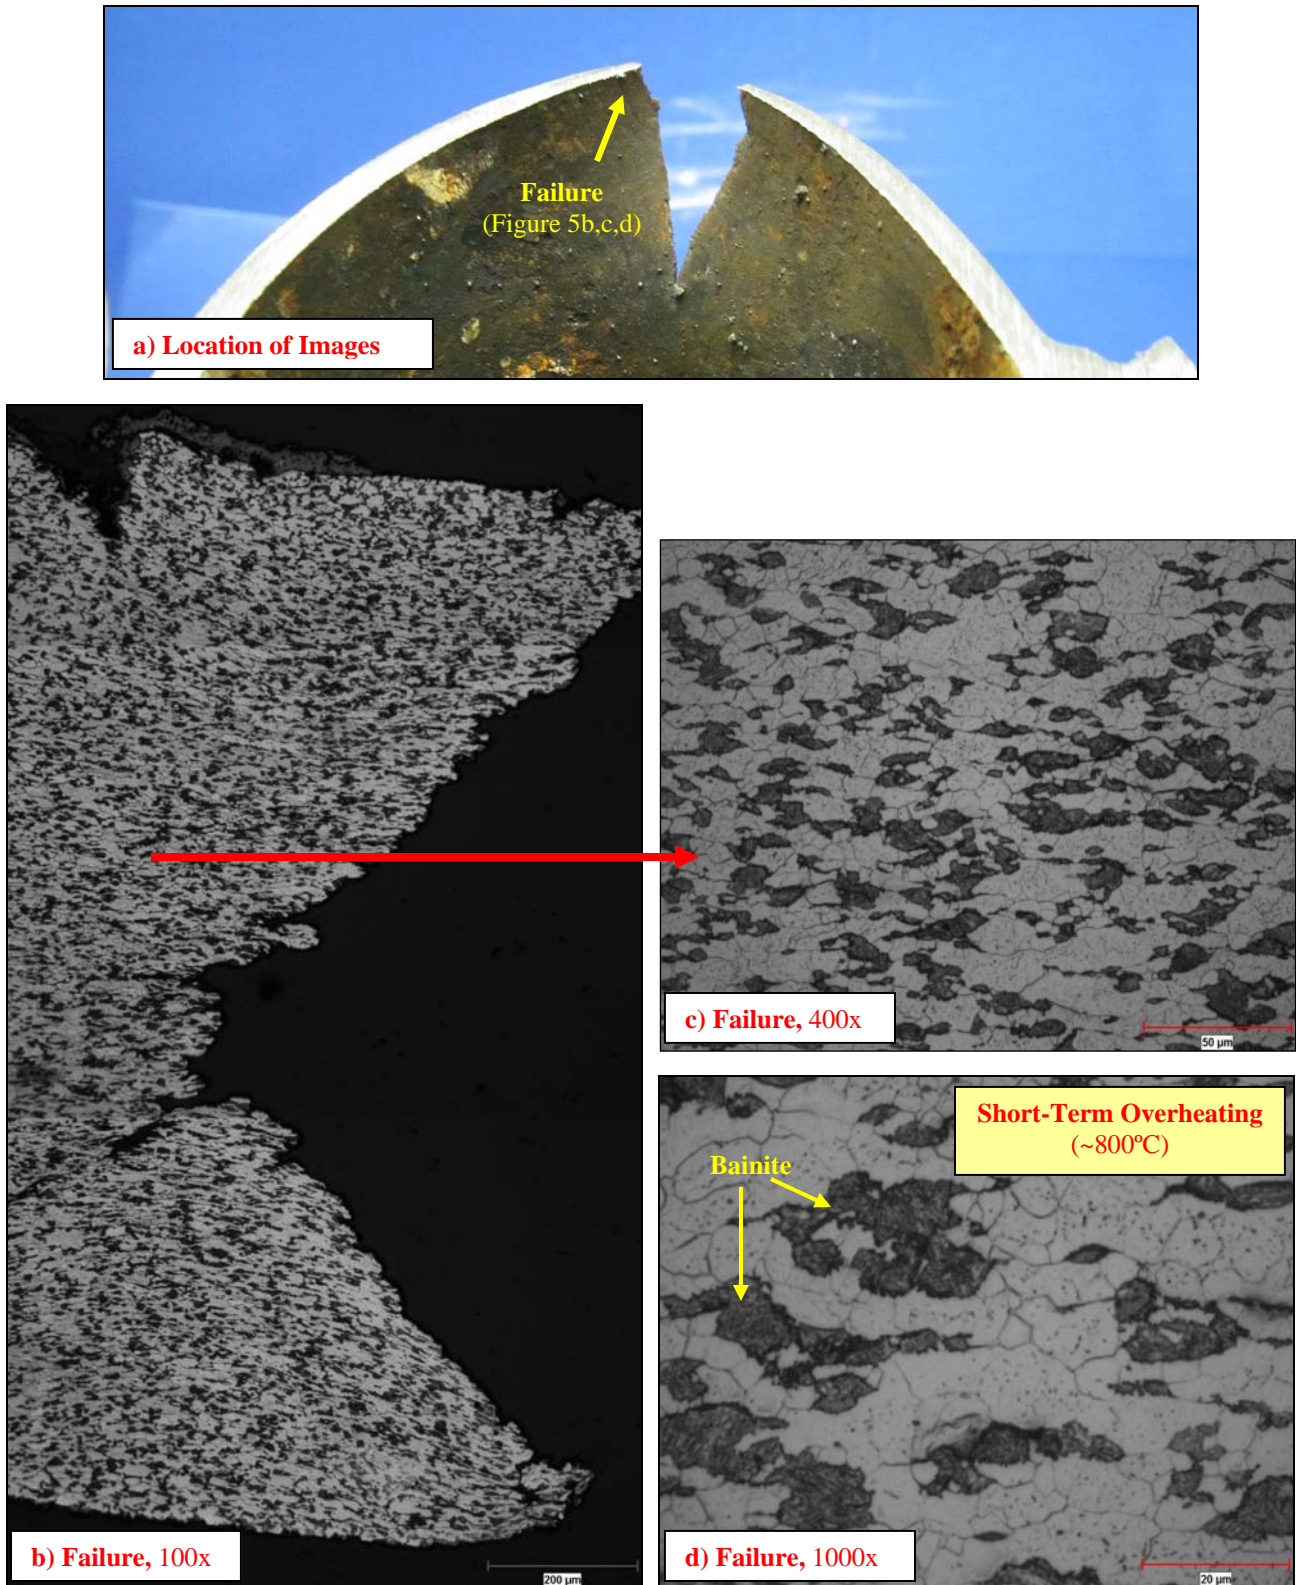
The rupture of Failed Tube #69 exhibited a mild fish-mouth morphology (**Figure 3**). The full tube perimeter was cut at the location of failure and examined by optical microscopy. The fireside wall, remote from the failure, exhibited significant thermal degradation in the form of spheroidization from long-term overheating (prolong exposure at temperatures up to 727°C / 1340°F, **Figure 4d,e**). The region of failure itself exhibited a partially bainitic structure, indicating this region had reached a maximum temperature of approximately 800°C / 1475°F at the time of failure (**Figure 5**). At this high temperature, the steel would have been partially austenitic and had significantly reduced strength, resulting in overload from the internal pressure. Once ruptured, the steam flow would have increased, quenching the steel to form bainite.

Figure 5: Micrographs displaying the initiation region to comprise of deformed ferrite and bainite. The bainite indicated that this region had reached an approximate maximum temperature of 800°C (~1475°F) at the time of failure. The elevated temperature resulted in reduced material strength, causing rupture failure.
