IN-SITU METALLOGRAPHY DAMAGE SURVEY OF A FAILED STEAM BOILER

EXAMPLE REPORT

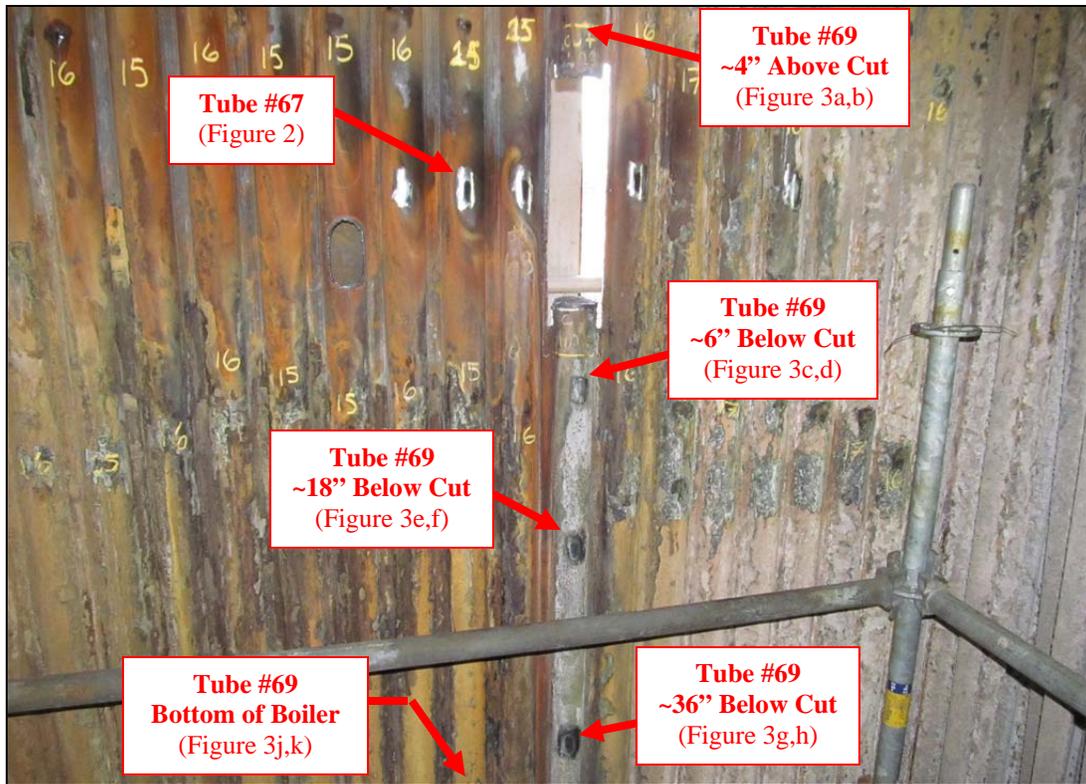
Figure 1: Photograph displaying the locations evaluated on the Failed Tube #69.

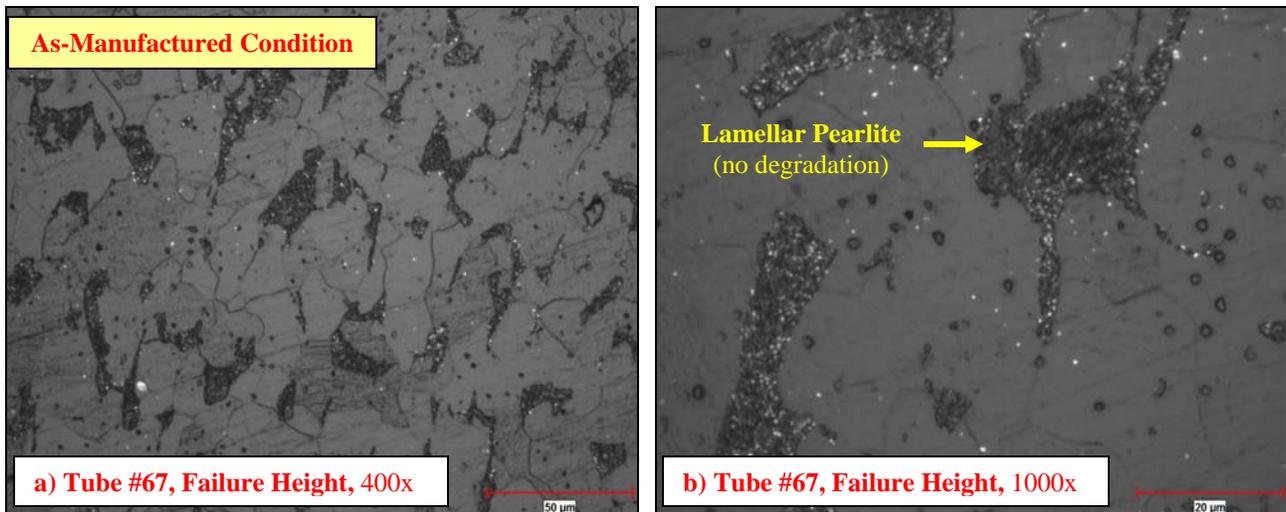
Figure 2: Micrographs taken from replicas of Tube #67 at the same height as failure of Tube #69. The microstructure comprised of ferrite and lamellar pearlite, typical for the as-manufactured ASTM A192 tube (ie. as-new structure, not degraded). This provided a benchmark to which the degradation of Tube #69 was compared against.

Images taken from replication, tube etched with 3% nital.

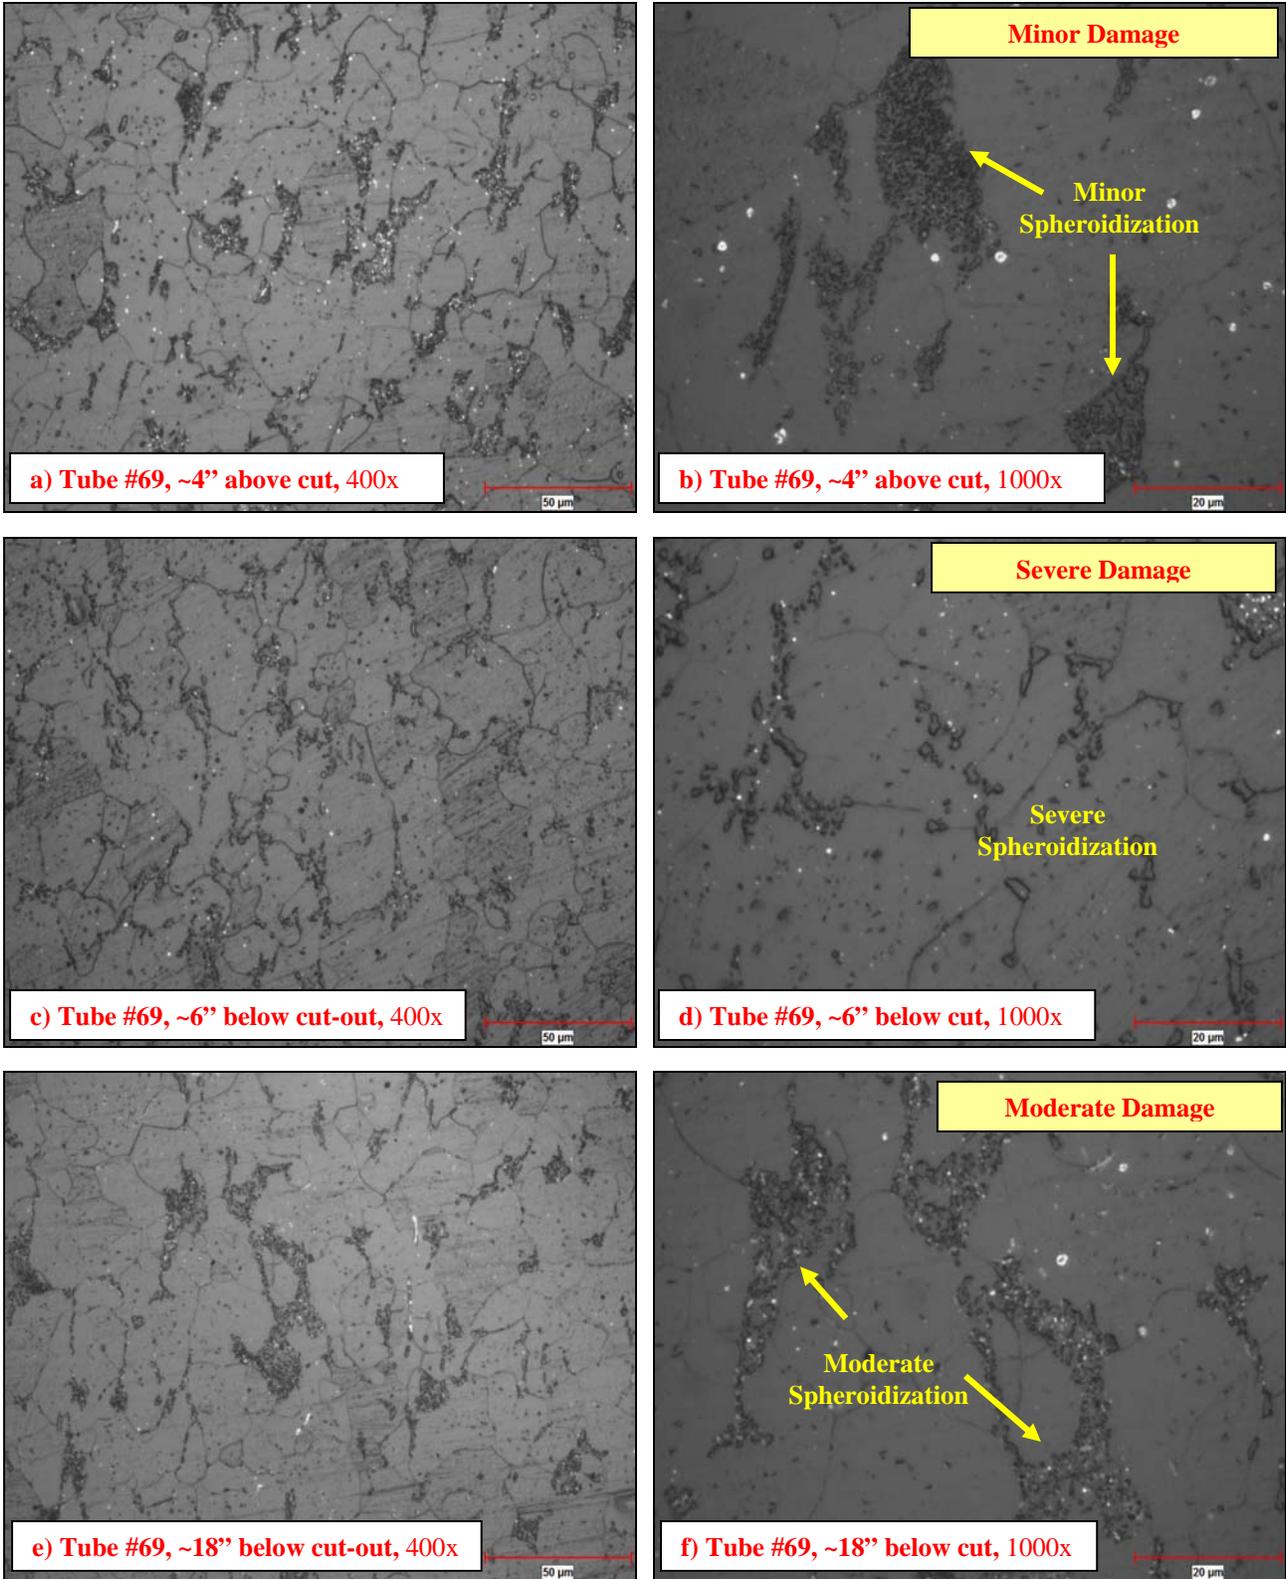
Tube #69 exhibited severe spheroidization immediately beneath the cut-out (**Figure 3c,d**). This damage was caused by long-term overheating. Inspectors had found a blockage at the base of the tube and the observed thermal damage matched well with reduced steam flow (ie. reduced cooling). Note that spheroidization results in reduced material strength and, combined with creep damage sustained from the elevated operating temperatures, can result in failure.

Tube #69 exhibited moderate degradation 18 inches below the cut-out (**Figure 3e,f**) and slightly less degradation at 36 inches below (**Figure 3g,h**). At 4 inches above the cut-out, the material exhibited only minor degradation (**Figure 3a,b**). The tube at the bottom of the boiler was in good condition (**Figure 3j,k**).

Figure 3: Micrographs of Failed Tube #69 (a,b) above the cut-out, (c-h) at various locations below the cut-out and (j,k) at the bottom of the boiler. The degradation was most severe immediately below the cut-out. Tube #69 was in good condition at the base of the boiler.

Due to the extent of thermal damage on the Tube #69 adjacent the region cut-out, it is recommended that additional tube material be removed during the repair. It is recommended that the owner consider further removing (a) four inches above the cut-out and (b) 36 inches below the cut-out in an effort to remove the most severely damaged material.

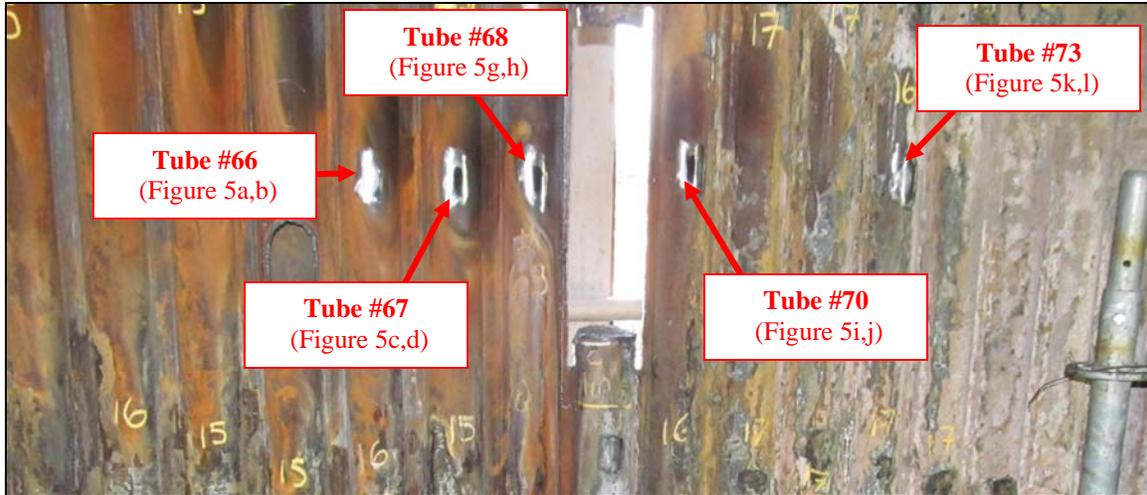
Figure 4: Photograph displaying the locations evaluated on the neighbouring tubes adjacent to the failure. These tubes were evaluated at the same height as failure, plus Tube #68 was evaluated at the boiler bottom.

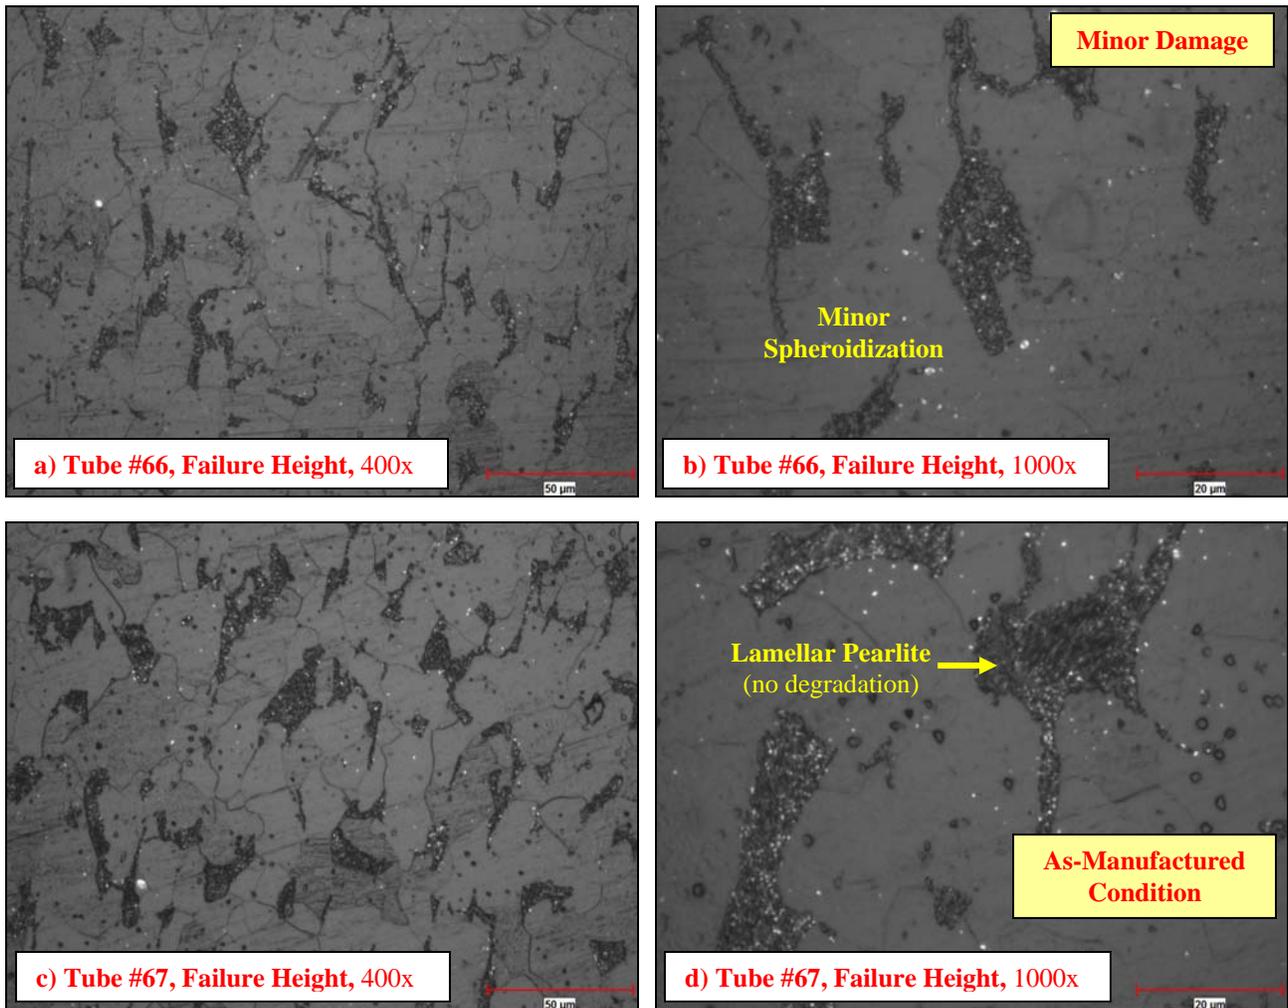
In-situ metallography of the neighbouring Tubes #66, 67, 68, 70 and 73 found them to be in relatively good condition considering their years of service (**Figure 5**). At the locations evaluated, these tubes had experienced lower service temperatures and thus, had not likely experienced similar blockages as Tube #69.

Figure 5: Micrographs of the neighbouring tubes to the failure. These tubes had not experienced the same, elevated temperatures during service as Tube #69 and were in good condition given their years of service.
