Steel Image Inc., Failure Analysis and Metallography
7 Innovation Drive, Suite 155, Flamborough
Ontario, Canada, L9H 7H9, (289) 895-8363

IN-SITU METALLOGRAPHY OF BOILER TUBES

EXAMPLE REPORT

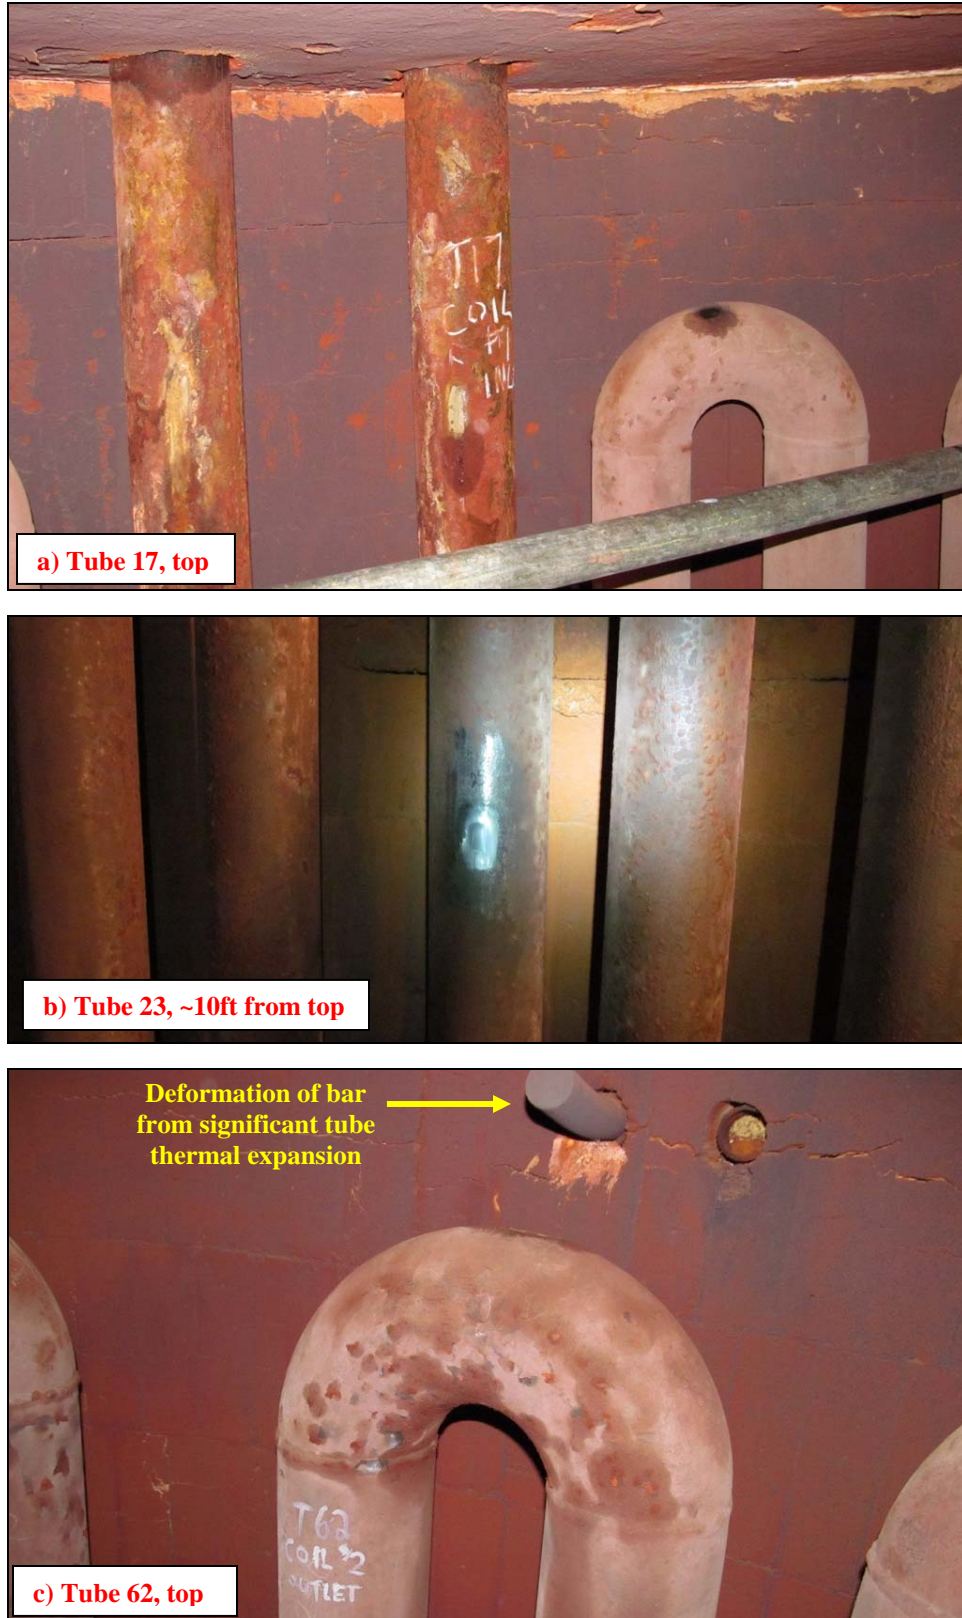
The bainitic structures matched well with the theory of gas flow interruption during operation. An interruption in the gas flow resulted in severe overheating of the tubes. During re-introduction of the gas flow, the tubes were quenched at a moderate rate, forming the bainitic structure. Also note that significant thermal expansion had occurred, evident from the deformation of a bar well above the outlet tube (**Figure 1c**).

Figure 1: Photographs displaying the locations originally selected for evaluation. Subsequent testing was also conducted at locations exhibiting diametric growth. Due to overheating, the tubes had experienced significant thermal expansion.

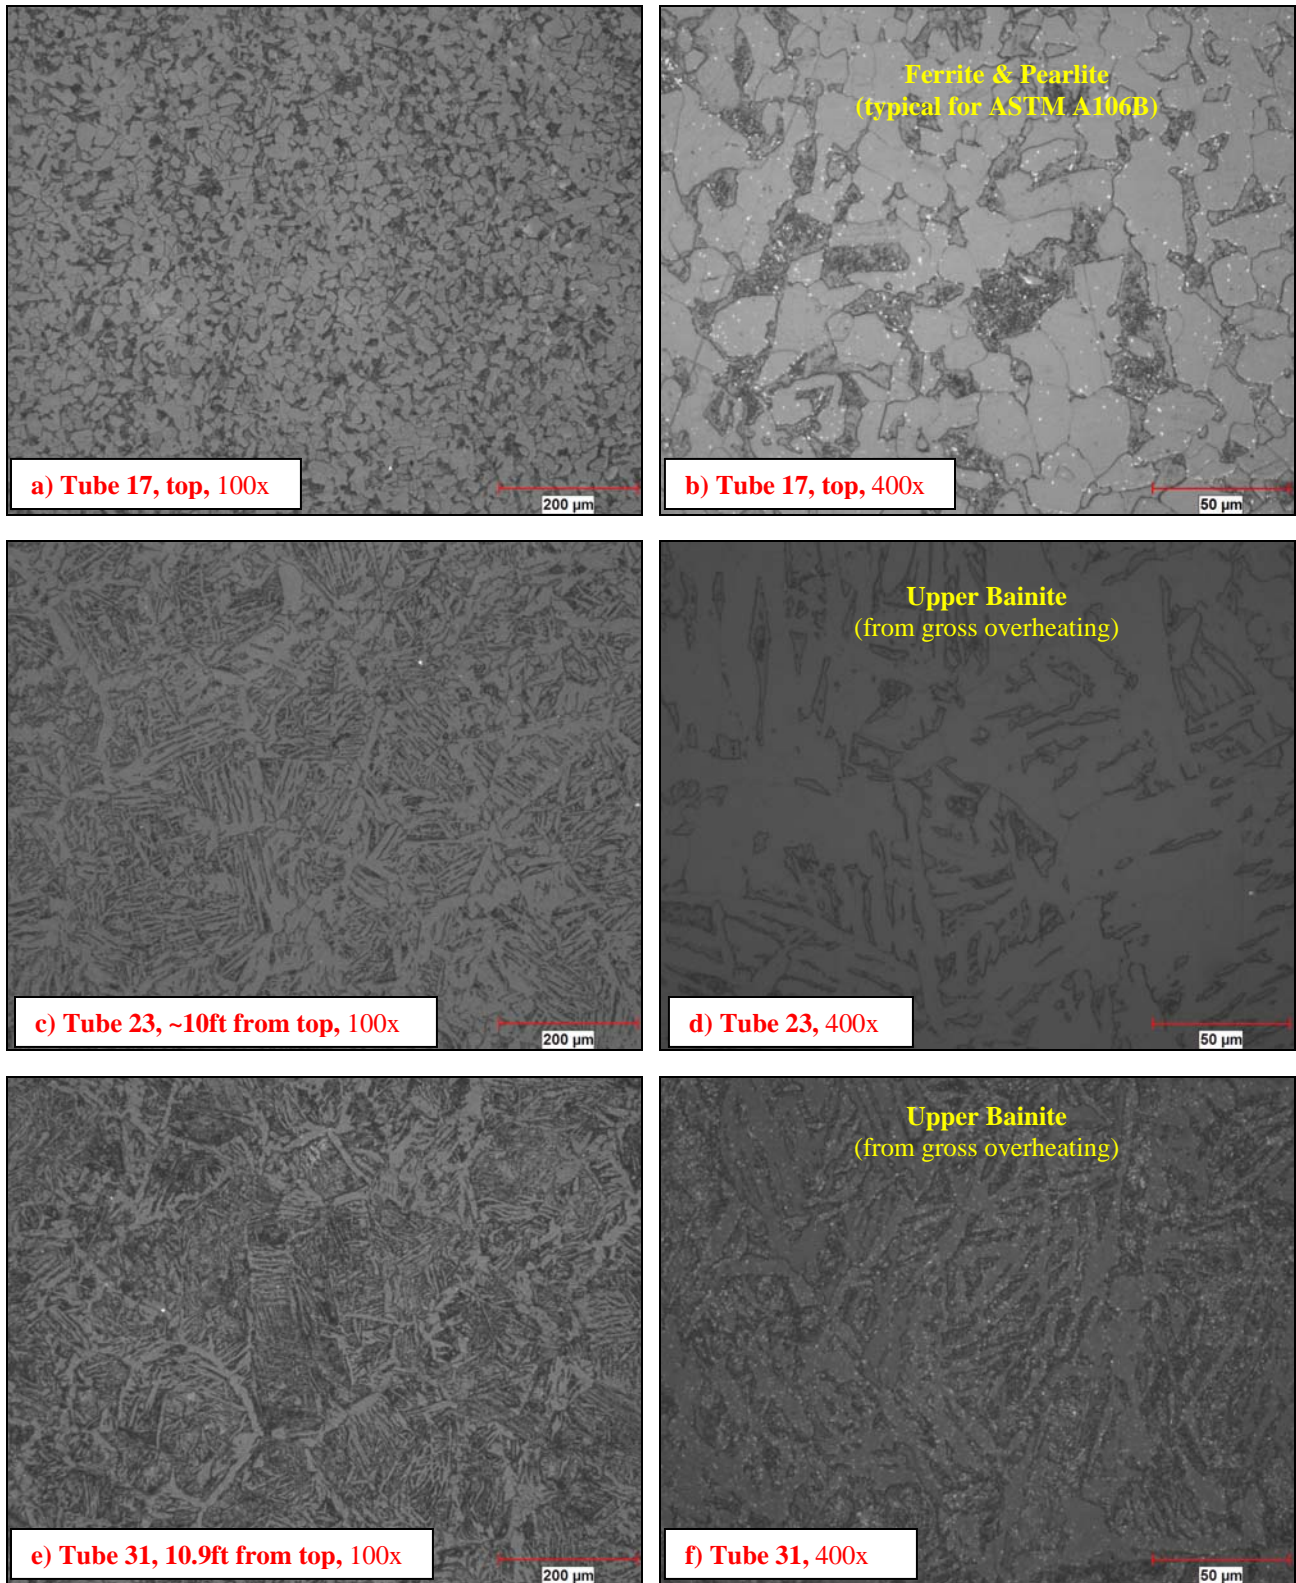
Inlet Tube #17 (coolest tube) comprised of a ferritic and pearlitic structure typical for this material. The other three tubes evaluated all exhibited upper bainitic structures. These structures indicated that these tubes had experienced an excursion above 1600°F (>871°C), then cooled relatively quickly. No creep voids or cracking was observed.

Figure 2: (a,b) The Inlet Tube #17 comprised of a structure typical for an as-manufactured ASTM A106B carbon steel. (c-j) The structures at other locations, including those exhibiting diametrical growth, comprised of upper bainite. These locations had reached temperatures above 1600°F. Images taken from replications.

Upper bainite was not deemed an overly detrimental phase yet its formation had removed the original structure manufactured to conform to the mechanical requirements. Therefore, the strength of the tube material would be expected to vary and may not conform to the design properties. It is recommended that the operator further review the effects of such an altered tube structure would have upon the safe operation of the boiler. Note that the tubes appeared to have operated without issue since the excursion.
