FAILURE ANALYSIS OF A RUPTURE BOILER TUBE

FAILURE ANALYSIS OF A RUPTURED BOILER TUBE

A refinery boiler had experienced a rupture failure on Tube #69 of the east water wall near the roof tubes. The tube material was ASTM A192 plain carbon steel and had been in service for approximately thirty years.

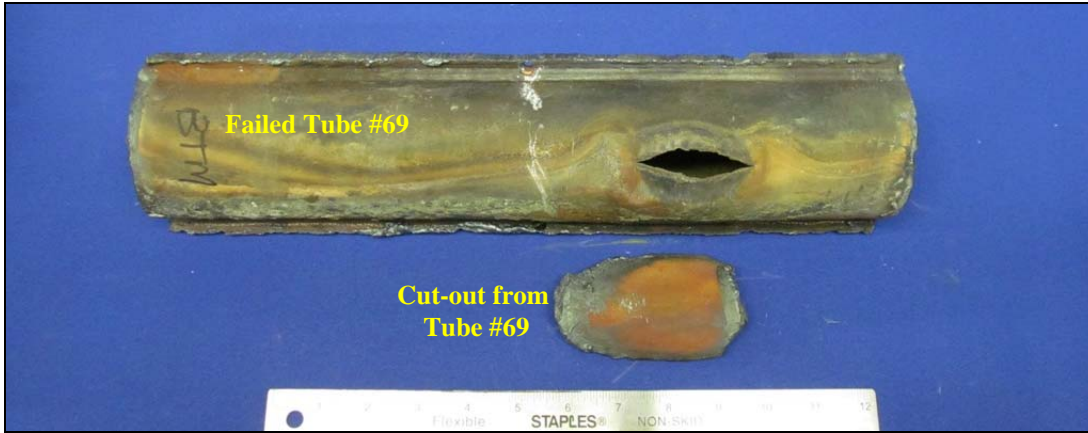
The ruptured section of Failed Tube #69, and a sample from the fire side of Tube #65 at approximately the same elevation as the rupture, were provided for analysis (**Figure 1**). Optical examination found Tube #65 to exhibit a microstructure typical of as-manufactured ASTM A192 steel (ie. no service degradation, **Figure 2**). Therefore, this tube had not experienced the same elevated service temperatures later found on the Failed Tube.

Figure 1: Photograph displaying the samples submitted for analysis including (1) the Failed Tube #69 and (2) a segment from Tube #65, at the height of failure.

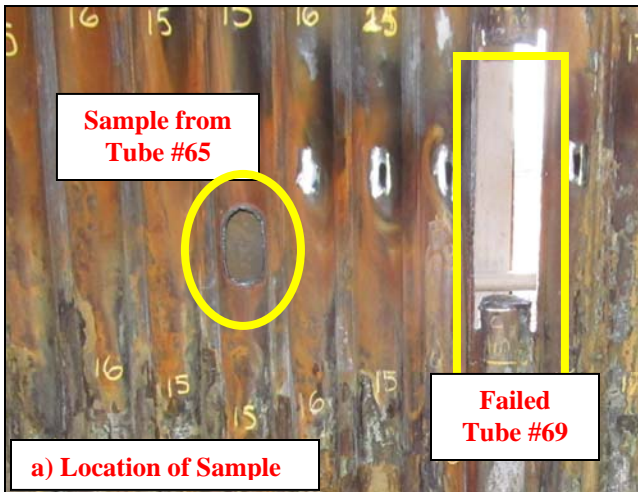
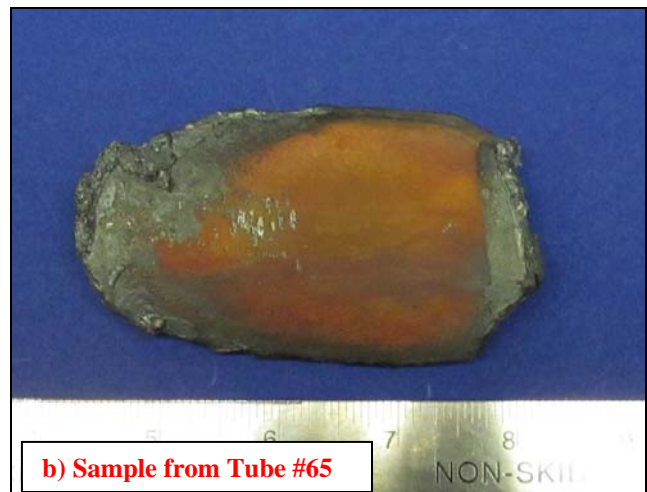
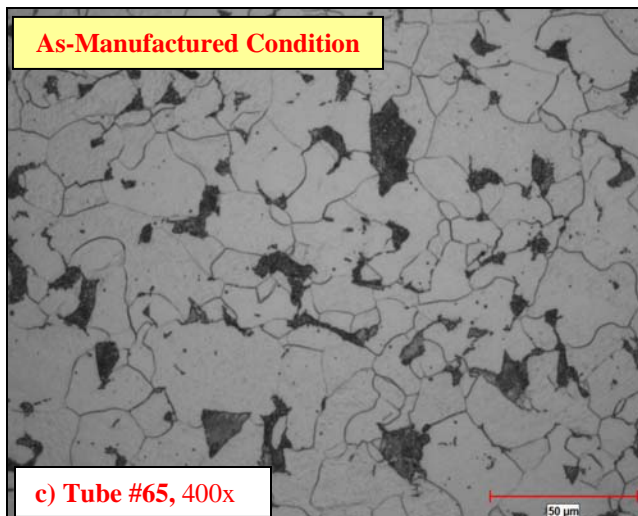
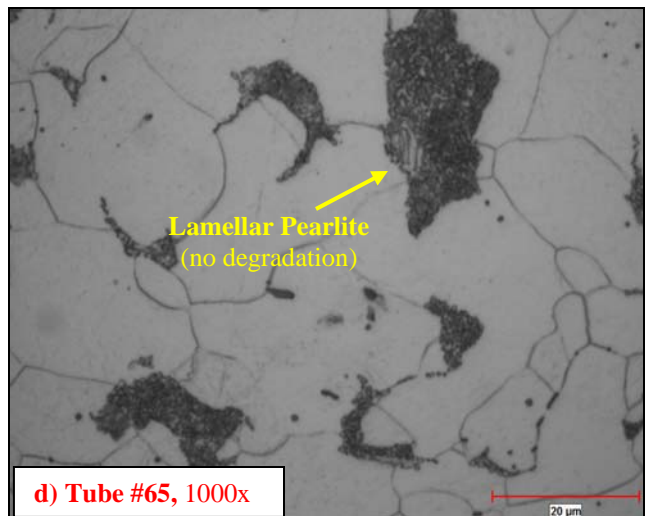
a) Location of Sample

b) Sample from Tube #65

c) Tube #65, 400x

d) Tube #65, 1000x

Figure 2: Photographs and micrographs of the sample taken from Tube #65. The core structure at this location was typical for the as-manufactured condition of ASTM A192 steel (ie. no service degradation). Etched using 3% nital.

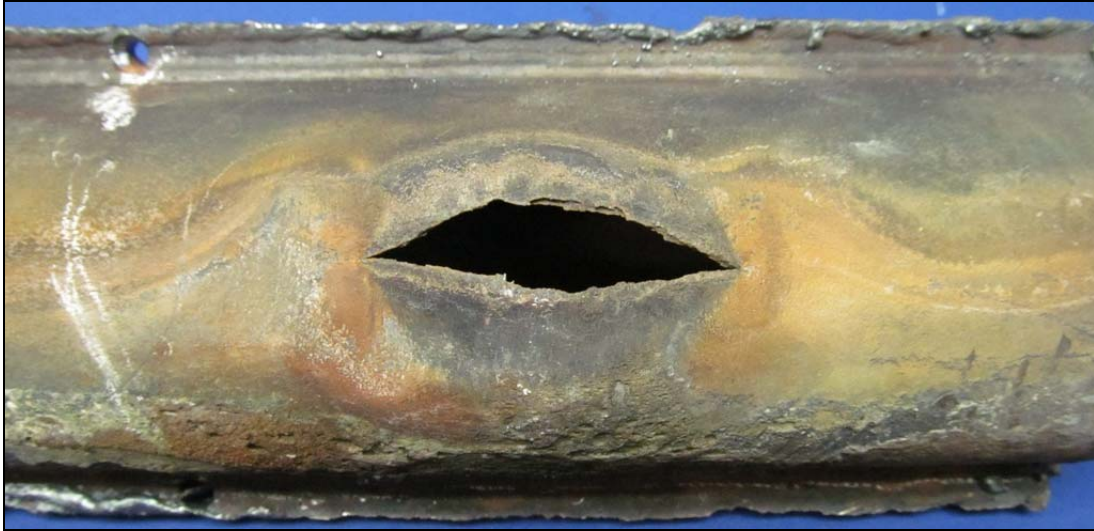
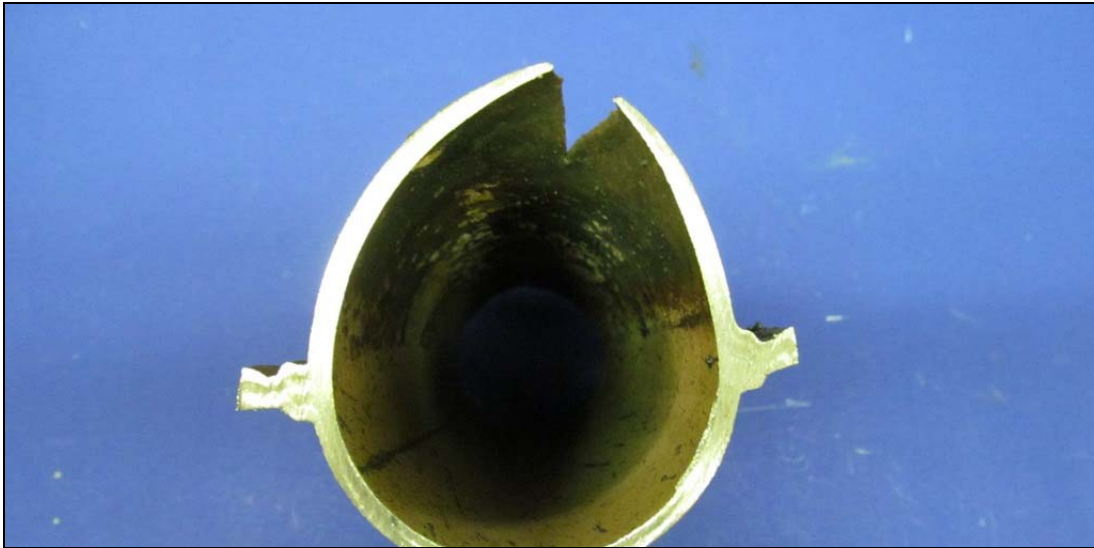
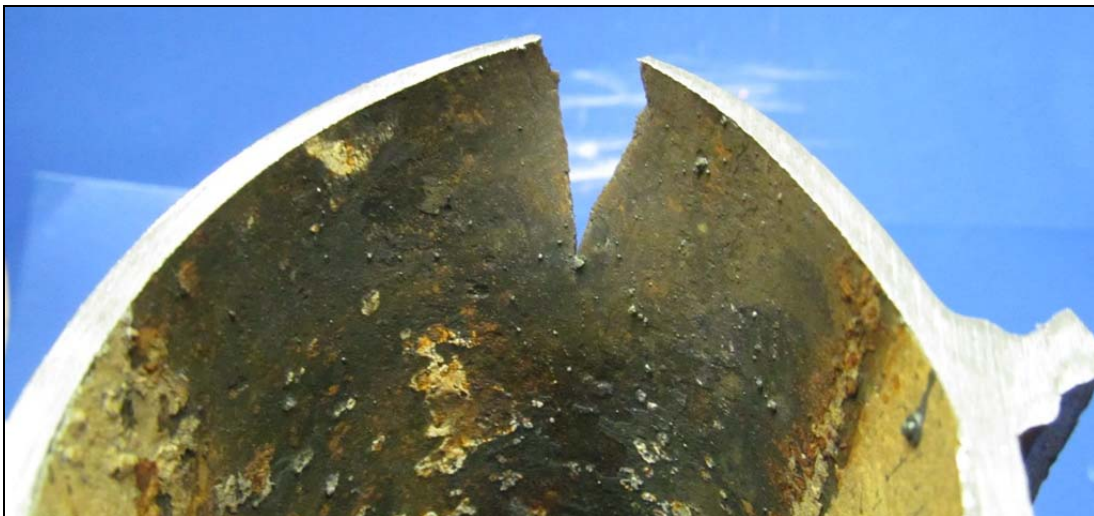
The rupture of Failed Tube #69 exhibited a mild fish-mouth morphology (**Figure 3**). The full tube perimeter was cut at the location of failure and examined by optical microscopy. The fireside wall, remote from the failure, exhibited significant thermal degradation in the form of spheroidization from long-term overheating (prolong exposure at temperatures up to 727°C / 1340°F, **Figure 4d,e**). The region of failure itself exhibited a partially bainitic structure, indicating this region had reached a maximum temperature of approximately 800°C / 1475°F at the time of failure (**Figure 5**). At this high temperature, the steel would have been partially austenitic and had significantly reduced strength, resulting in overload from the internal pressure. Once ruptured, the steam flow would have increased, quenching the steel to form bainite.

Figure 3: Photograph displaying the failure of Tube #69. The failure exhibited a mild fish-mouth morphology. Further analysis would find that the failed region had been overheated at the time of failure.

Tube rupture had occurred due to short-term overheating yet the tube had experienced prolonged, elevated temperatures. As the damage appeared isolated to this tube only (supported by on-site evaluation), tube failure had been the result of a tube blockage. Boroscope inspection by the refinery had found a suspected blockage at the base of the tube, matching well with this theory. The ruptured tube section was replaced and the boiler put back into service.

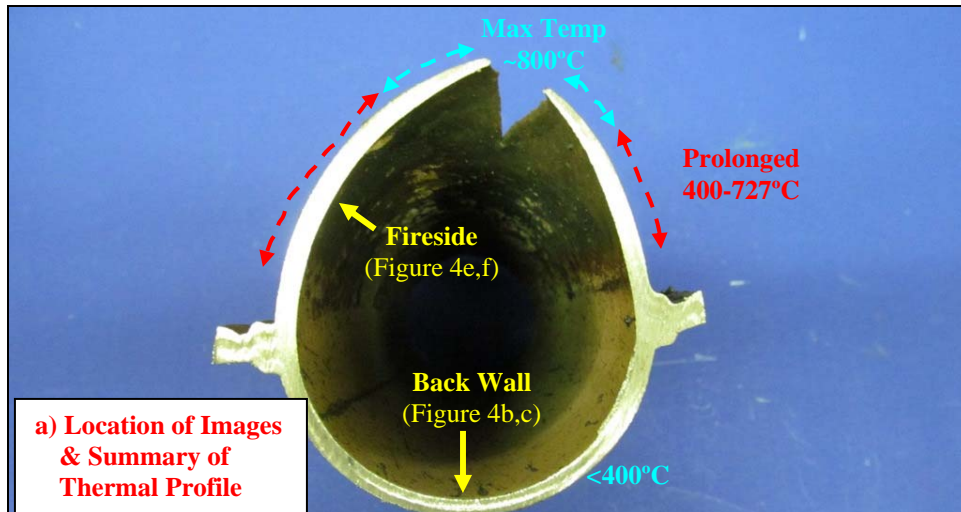
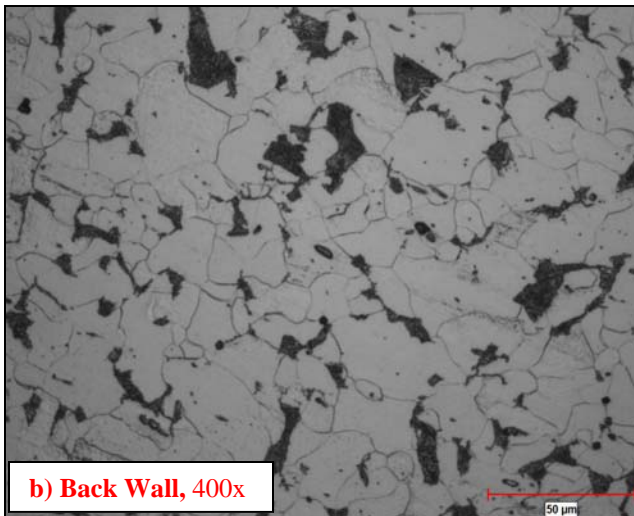
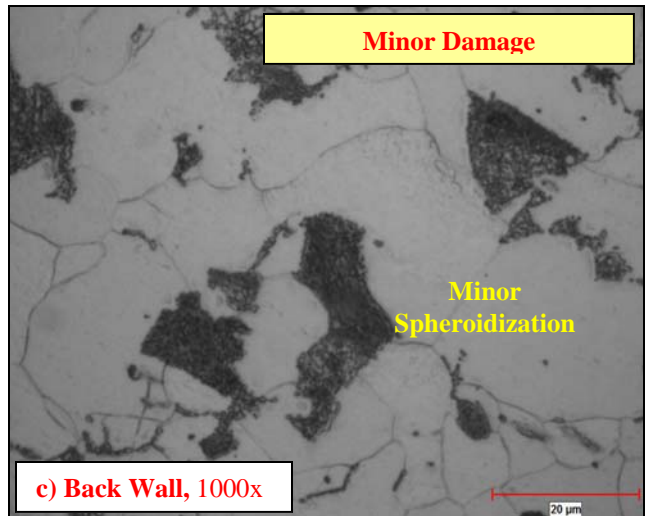
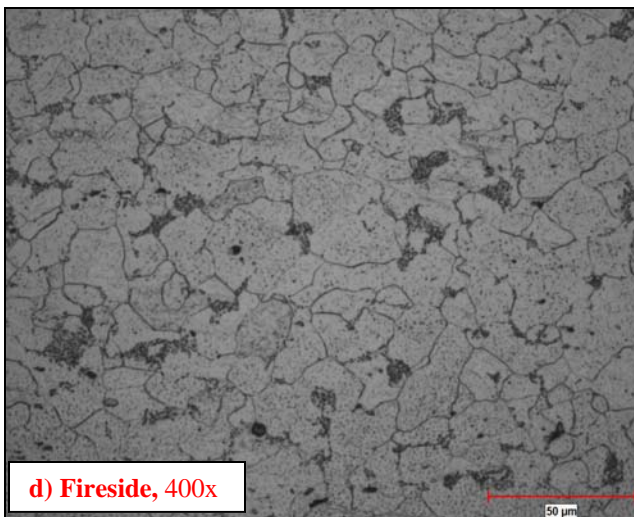
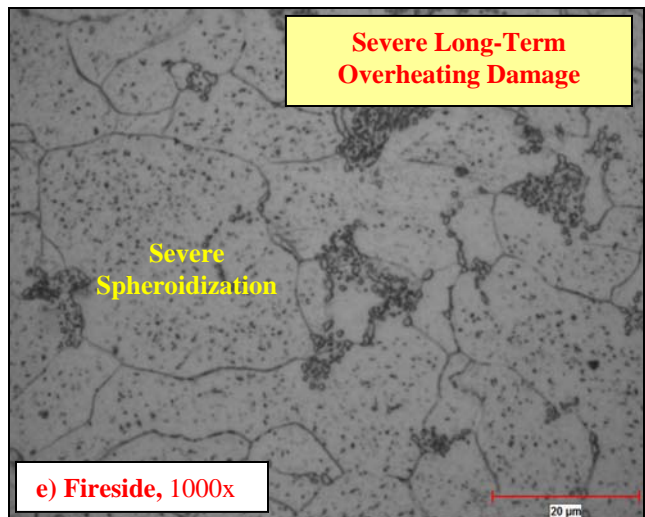
Tube #69 rupture was due to overheating. The tube had experienced long term overheating well above its rated temperature, causing thermal damage to the tube. Yet failure had not occurred until a small portion of the tube had reached temperatures in the order of 800°C / 1475°F. This short-term spike in temperature resulted in strength loss, causing rupture. **Figure 4a** provides a diagram with the thermal profile of the tube indicated.

Figure 4: (b,c) The back wall of Tube #69 exhibited only minor spheroidization/thermal degradation from service. (d,e) Portions of the fireside exhibited significant spheroidization/thermal degradation from long-term overheating (<727°C / 1340°F). Etched using 3% nital.

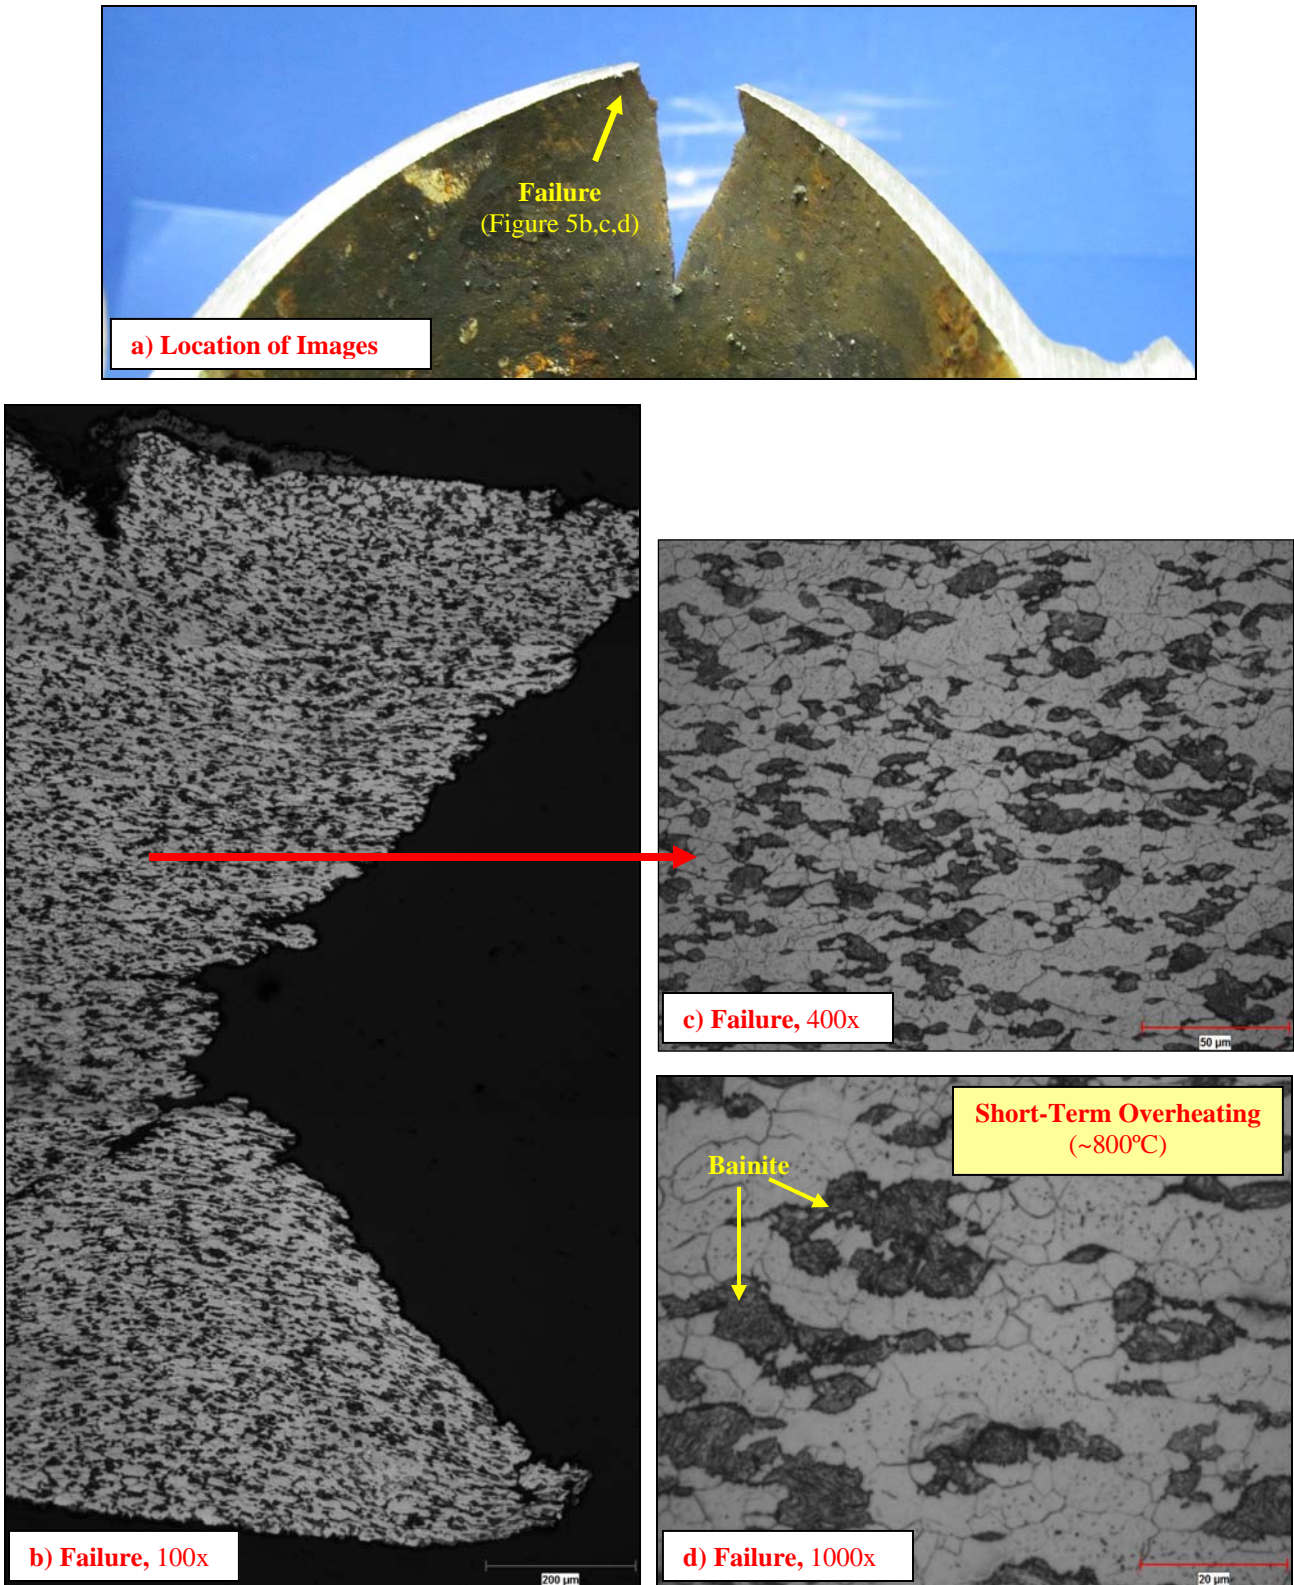
This sequence of failure matched well with the theory that a blockage specific to this tube had reduced steam flow, reducing the cooling of the tube. It was likely that a partial blockage had resulted in long-term overheating and, from continual worsening of the blockage, the temperatures had increased until rupture.

Figure 5: Micrographs displaying the initiation region to comprise of deformed ferrite and bainite. The bainite indicated that this region had reached an approximate maximum temperature of 800°C (~1475°F) at the time of failure. The elevated temperature resulted in reduced material strength, causing rupture failure.

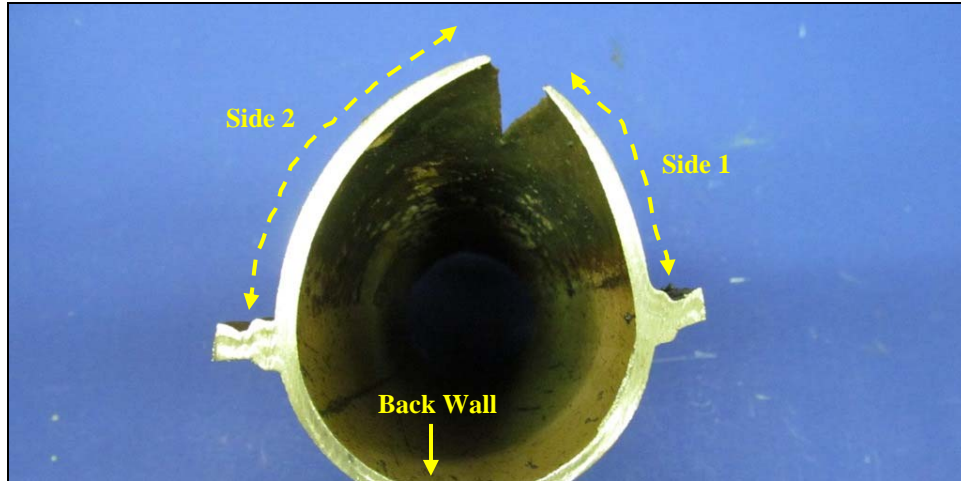
Table 1: Microhardness Test Results of the Failed Tube #69*

Hardness testing was conducted in the transverse orientation on Tubes #65 and #69. **Tables 1 and 2** list the obtained results. The hardness along the fireside of Failed Tube #69 varied significantly due to the alteration of the microstructure from (a) long-term overheating and (b) reaching temperatures above 727°C.

Distance from Failure (mm)	Side 1		Side 2	
	HV _{500gf}	HRB	HV _{500gf}	HRB
1	149	80	148	79
2	150	80	140	76
3	145	78	145	78
4	161	84	154	81
5	156	82	165	85
10	151	80	160	83
15	151	80	153	81
20	133	73	145	78
25	134	74	144	78
30	134	74	129	72
35	140	77	128	71
40	147	79	128	71
45			134	74
50			124	70
55			121	68
60			127	71
65			125	70
70			133	73
Location	Measurements (HV_{500gf})		Avg. Hardness	
			HV_{500gf}	HRB
Back Wall	130, 129, 118, 123, 127		125	70

*Hardness testing conducted in the transverse orientation around the tube perimeter as illustrated in the picture above.
